Product Alert

Type of Notification: Performance-related Concern

FM Approvals is aware of three instances where Tyco Model RAF-80 pressure relief valves have experienced delamination of their interior coating.

Description: Water Pressure Relief Valves

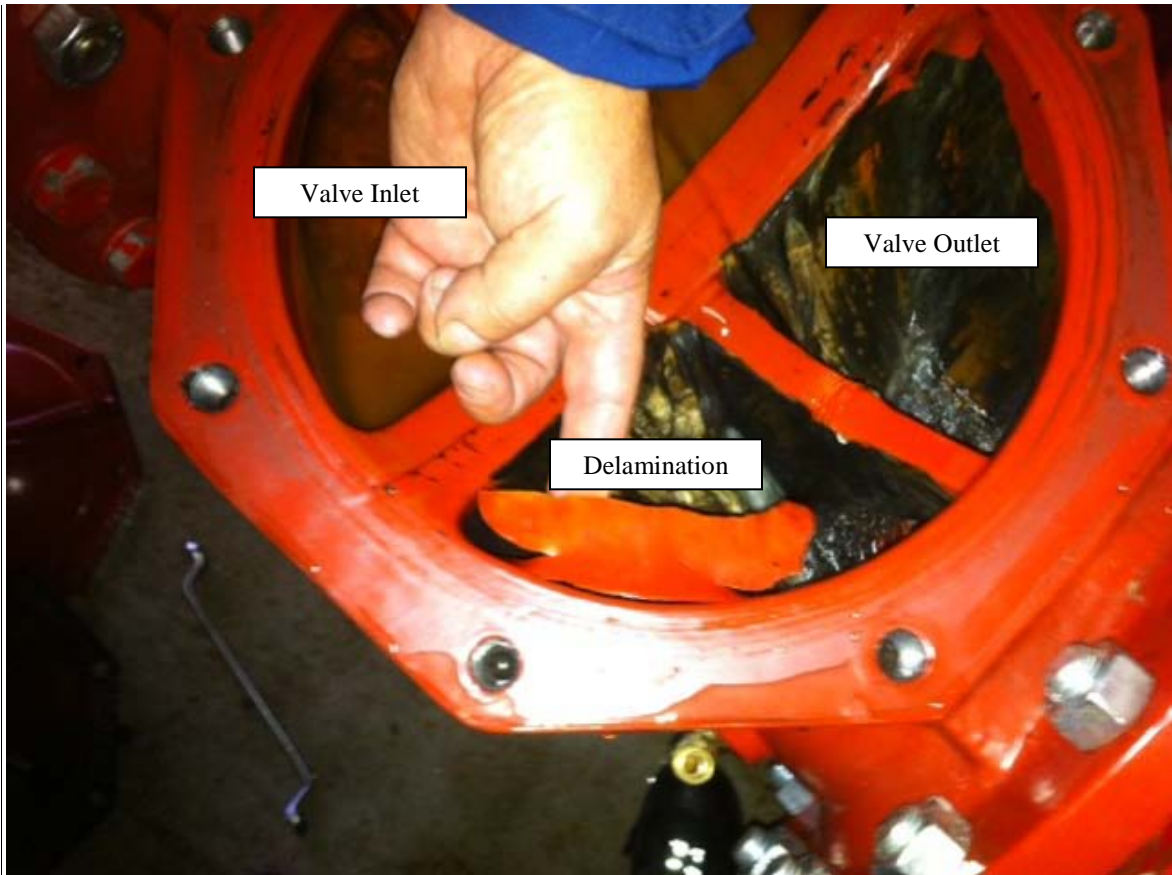
Hazard Involved: FM Approvals is aware of three (3) instances where Tyco/Raphael Model RAF-80 pressure relief valves have experienced delamination of their interior coating. The delamination appears to be limited to the downstream side of the subject valves (see Figure 1) and may be further limited to larger size valves (e.g; 6" or 8")

Figure 1 above shows typical delamination of the interior coating on the downstream side of an 8" Model RAF-80 water pressure relief valve.

Sprinkler systems which incorporate these devices should be given an in-depth inspection to include removal of the Model RAF80 valve cover to examine the downstream side of the valve for indication of delamination. Additionally, strainers found in the cooling loops of diesel engine drivers and other fire protection devices should be inspected and cleaned, if necessary.

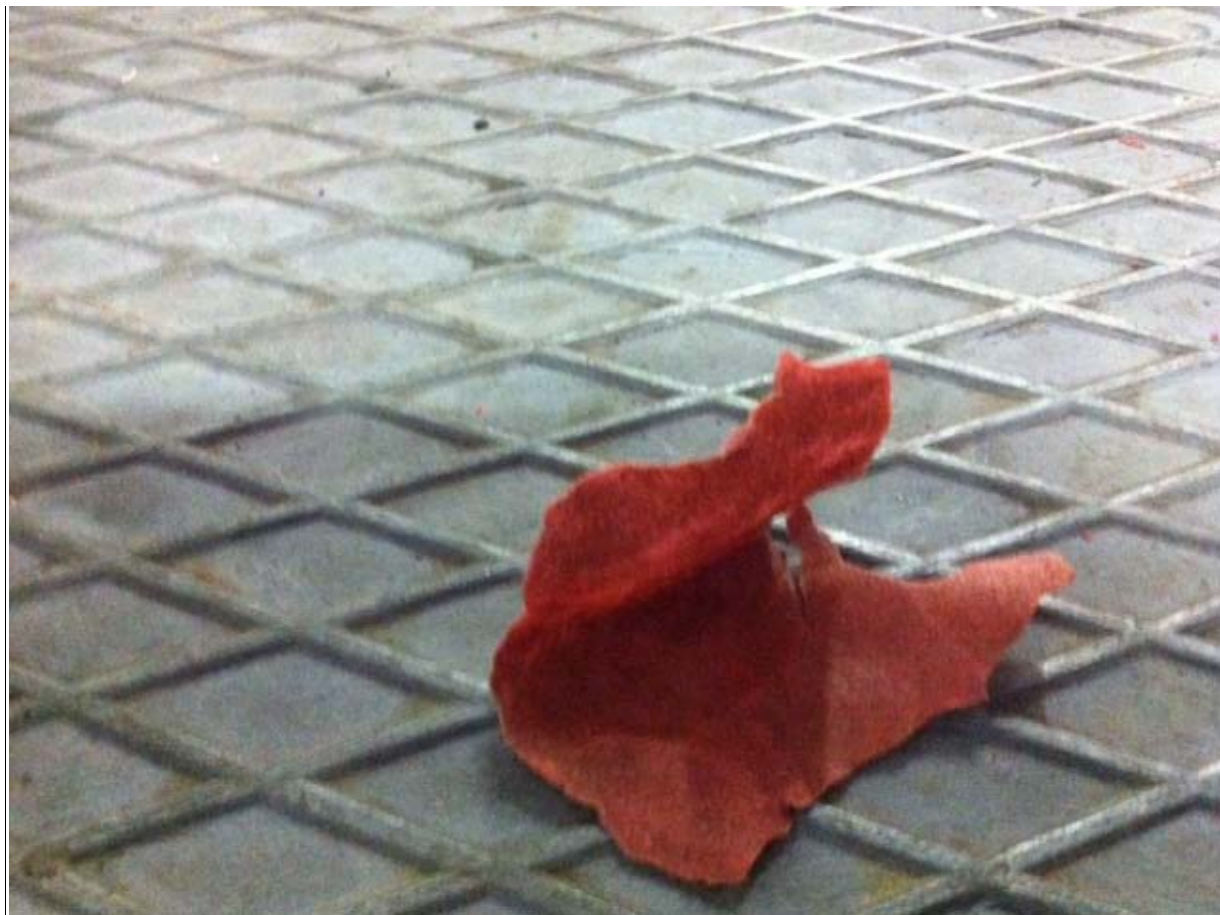
The delaminated fragments (see Figure 2) can pose serious threats to the proper operation of the fire protection system. These threats are of particular concern when the discharge of a system water relief valve is piped back into a pump suction supply tank. This scenario may allow the fragments to be re-ingested into the fire pump and subsequently the sprinkler system piping, or the fire pump driver (diesel engine) cooling loop. The reports received by FM Approvals involved clogging the cooling water line to the diesel driver and burnout of the engine.

- If fragments of the coating pass into the sprinkler system they may clog, impede or disturb the proper flow of water through system piping or sprinkler heads with a deleterious effect of water flow and sprinkler head distribution.
- If fragments are drawn into the cooling loop of a diesel engine, the strainer supplied within the cooling loop of the engine will trap the fragments. However, a buildup of fragments will eventually restrict water flow, and potentially block cooling loop water flow completely. This restriction or blockage will result in inadequate cooling of the engine and lead to engine failure if not detected.

Figure 2 shows a fragment of delaminated coating from a Model RAF-80 water pressure relief valve.
