Product Alert

Type of Notification: Product Safety Notification

PRODUCT NOTICE

Subject: Pulsar 4 and Pulsar 4 Advanced hazardous area usage warning

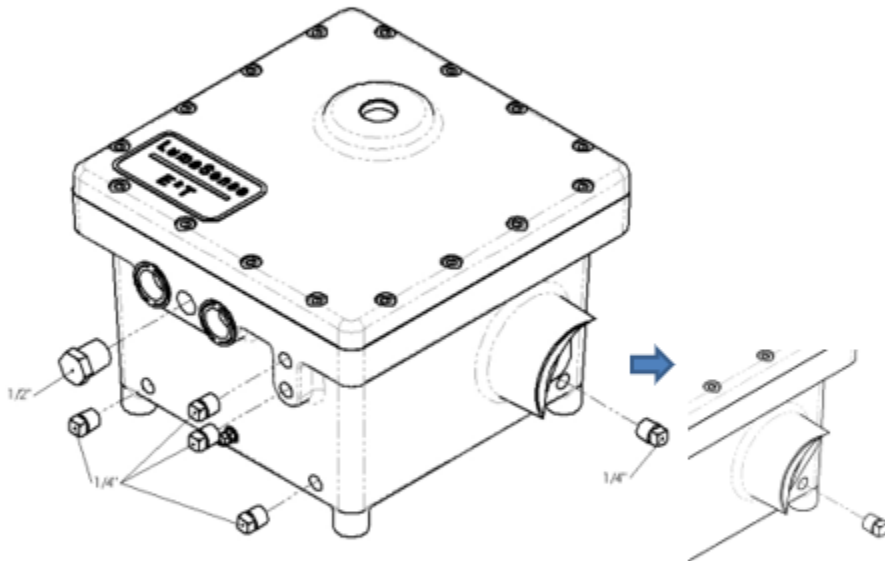
This notice is to advise the users of the Pulsar 4 and Pulsar 4 Advanced devices that it has been discovered that some of the enclosures have porosities in their casting which could reduce the strength of the enclosure in terms of explosion safety and may also allow water entering into the main electrical compartment if the water-cooling base is used.

Problem description: The investigation revealed that these porosities could have occurred where there is asymmetric pouring and uneven cooling during the casting process which cannot be visually observed during the casting process. This led to the potential cause of porosities in the bottom area of the enclosure. A new pouring concept was established and tested for symmetric pouring conditions and uniform cooling to prevent inclusions and porosities that could lead to leakages.

- Remove the existing 3/4 inch and 1/2 inch stopping plugs on the product and replace them with the ATEX/IECEX rated Ex db IIC Gb 3/4 inch NPT and ATEX/IECEX rated Ex db IIC Gb/ Class I Division I Groups A, B, C & D 1/2 inch stopping hexagon socket plugs supplied with this notice and by following the replacement instruction below.

Replacement Instructions: To ensure the certification of the internal Ex proof compartment, the indicated plugs as shown in the picture should be replaced as follows:

- The installation needs to be carried out by qualified Ex personnel
- No damage should occur to any thread or form during installation
- The threads need to be engaged wrench tight into the threaded hole
- A minimum of 5 threads engagement has to be maintained when tightened
- Conduct a visual check after replacing all stop plugs to ensure that no damage is on the plugs, threads or enclosure
