Product Alert

Type of Notification: Performance Related Concern

Date: December 1, 2011
To: Chemetron Fire Systems Distributors
From: Joseph Ciol, Product Manager
Subject: **Safety Bulletin 50260263** ½ inch CO2 Discharge Hose

Bulletin**#12-25C**

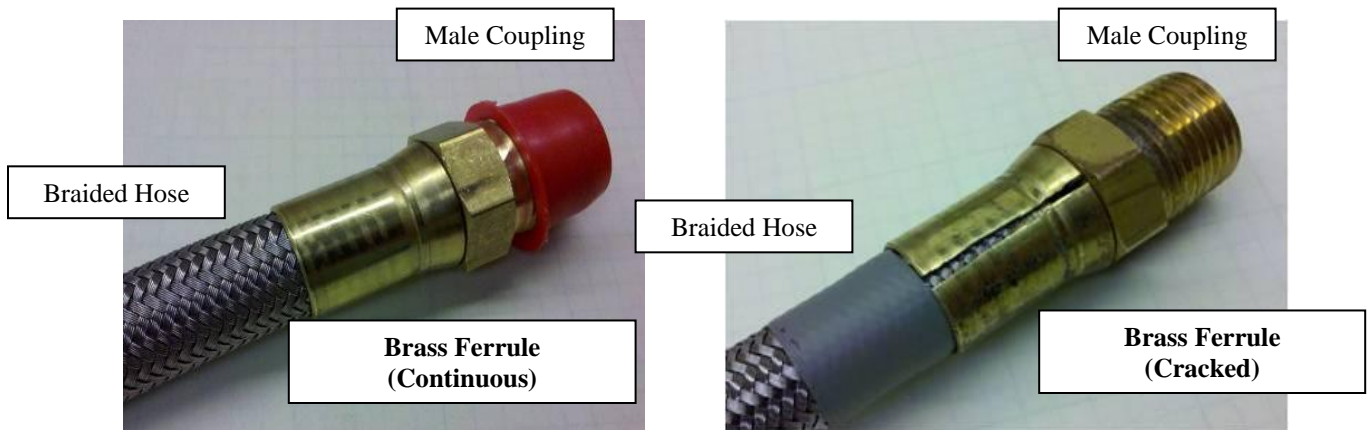
Example of correct ferrule condition

The brass ferrule is continuous (unbroken) around the entire circumference.

Example of incorrect ferrule condition (worst case complete longitudinal crack)

A crack or split of ANY length along the ferrule body on either end of the hose is cause for replacement.

1. Check your inventory and make the necessary arrangements to inspect hoses installed at your customer sites. A hose that exhibits a crack or split **of ANY length** along the ferrule body **on either end** of the discharge hose must be replaced immediately. An inspection mirror may be required to view the entire surface of the ferrule.

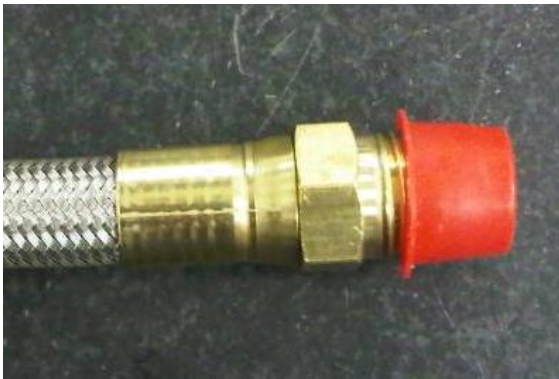
REPLACE

No marking on the coupling hex

2. Hoses shipped between June 2010 and March 2011, **that do not exhibit a crack along the ferrule but have no marking on the coupling hex (See Configuration A above), must be replaced at the next service interval.** Hoses removed from service must be rendered inoperative and disposed of to avoid the possibility of reuse. This can be achieved by cutting the hose in half or the removal of one of the fittings. Once again, only hoses shipped between June 2010 and March 2011 meeting Configuration A (no marking on the coupling hex) need to be replaced per this bulletin. Hoses meeting Configuration B are not subject to this bulletin.

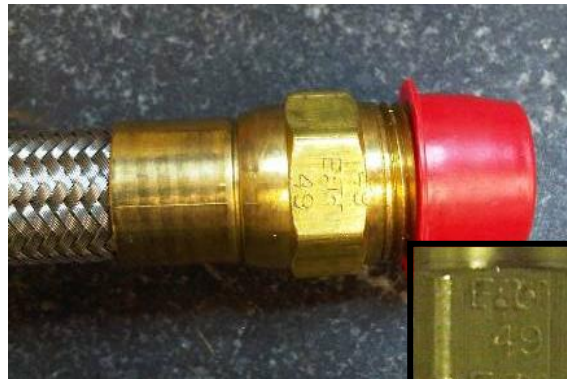
Configuration B

NO ACTION
REQUIRED

Supplier Identifier marking on the coupling hex

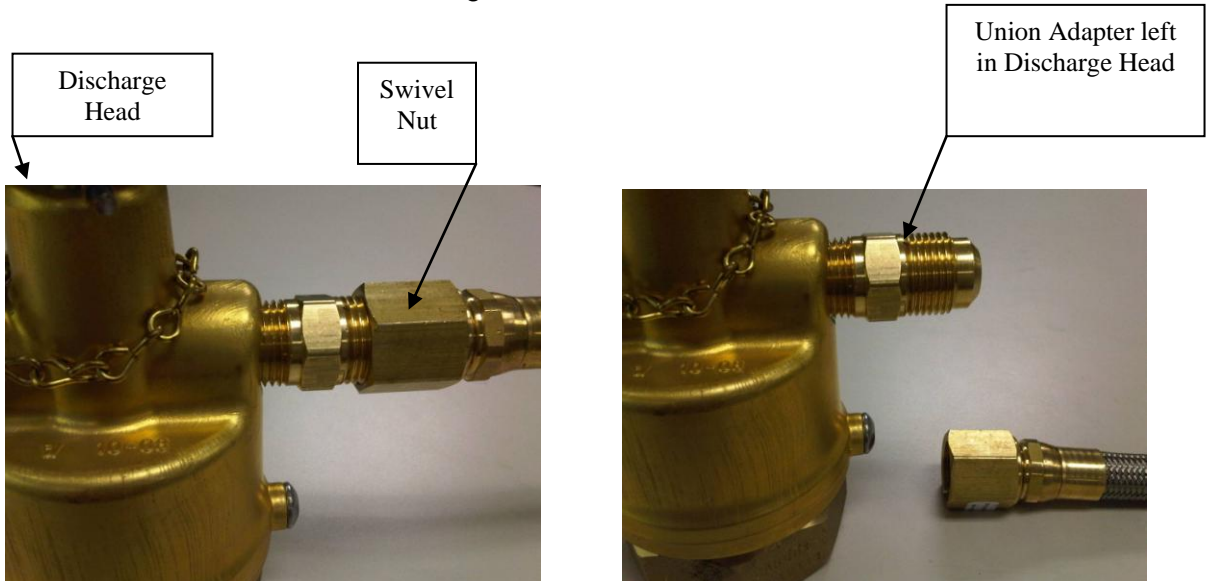
5. To accomplish the hose replacement follow standard procedure for disarming the system including removal of all the discharge heads in the system to avoid accidental discharge. Disassemble the **Swivel Nut** side of the hose first, leaving the **Union Adaptor** in the Discharge Head. Then remove the male end from the system piping. The new hose should then be assembled in the reverse order with the male fitting end first, then the swivel nut end into the union adaptor. Use a small amount of a good grade of pipe thread dope or Teflon tape on the threads when making these connections. Before connecting discharge heads to cylinders, make certain that the plungers of ALL discharge heads are in the *non-actuated* position (i.e., check the plunger to see that it is retracted). When the piston is in the non-actuated (retracted) position, the end of the plunger should be approximately 3/4" inside the bottom of the union nut. Reassemble the discharge heads.
