Product Alert

October 26th, 2018

Type of Notification: Safety / Performance Related Concern

Model: SPP Pumps Ltd. Pump packages driven with diesel engines 250hp and larger with Centaflex Model A coupling sizes 140 and 200.

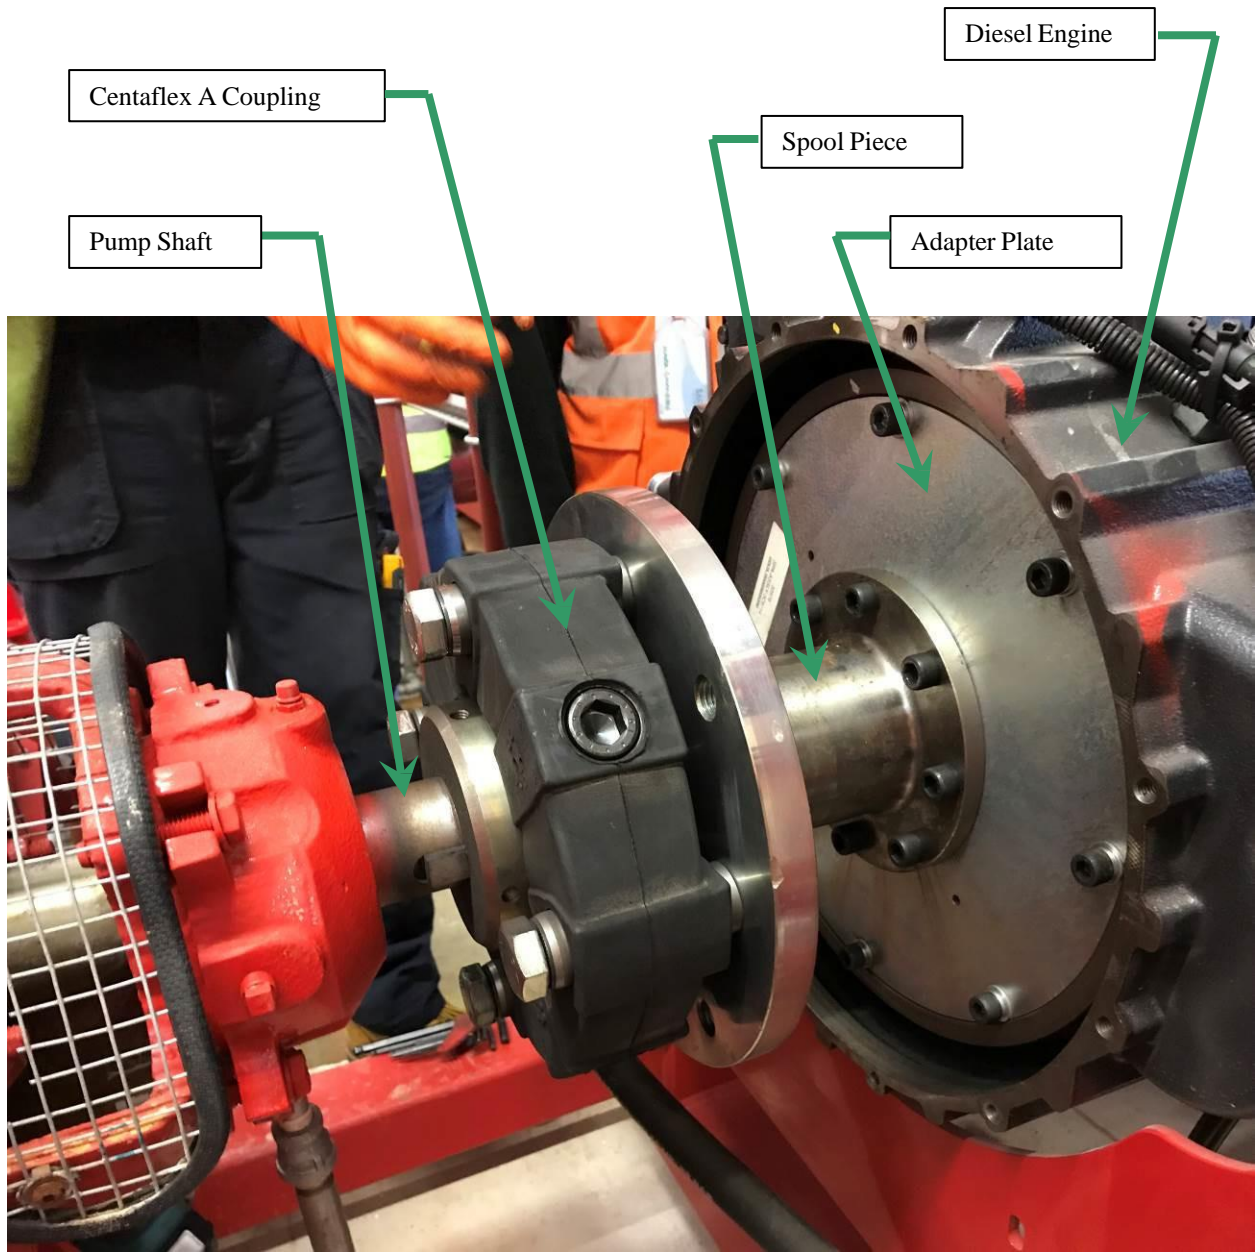
The coupling assembly consists of a Centaflex A coupling, a spool piece and the flywheel adapter plate which is mounted to the engine. (See Figure 1). There is evidence that coupling misalignment is a major contributor to the rate of adapter plate failure.

Figure 1 – Centaflex A pump coupling assembly.

Figure 1 highlights the components discussed in this Product Alert.

FM Approvals recommends the coupling be replaced for all SPP UK manufactured pumps which utilize the Centaflex Model A coupling sizes 140 and 200. SPP UK has coupling replacement kits which have different style couplings, thicker adaptor plates and a greater degree of acceptable misalignment which can be retrofitted to existing installations. For further information, contact the regional SPP representative or contact SPP directly using the contact information below. When any fire pump coupling is replaced the pump and driver must be properly aligned to within the coupling manufacturer's tolerance to ensure reliable operation.

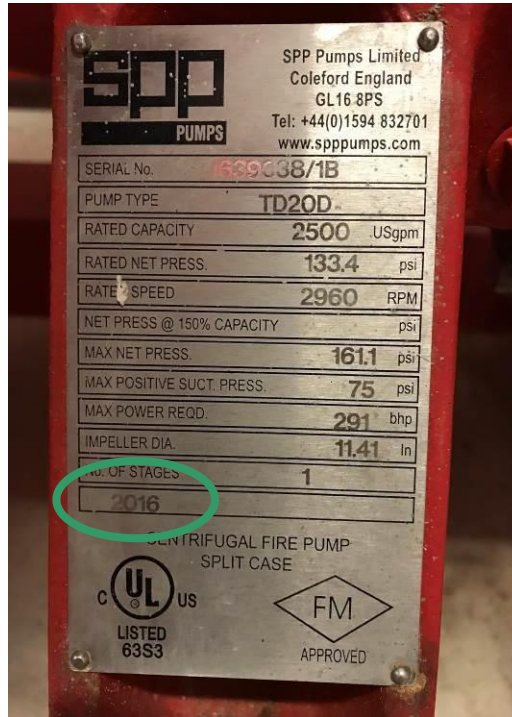
Date Codes Affected: SPP pump packages manufactured between June 2014 and January 2018.
(See Figure 2).

Figure 2 – Nameplate

Nameplates dated June 2014 through January 2018 are affected by this Product Alert.

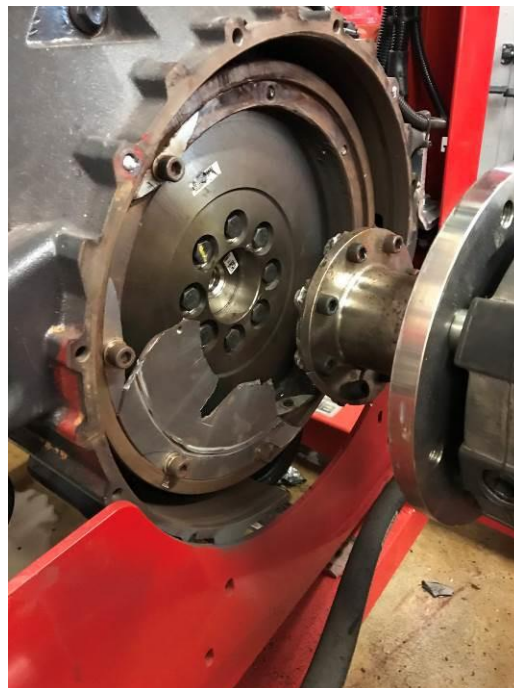
FM Approvals has been made aware of failures and cracking of diesel engine fire pump flywheel adapter plates manufactured by Centa and utilized by SPP UK.

These specific coupling components are susceptible to sudden failure which may result in the ejecting of coupling parts at high velocity. This sudden failure will disconnect the drive capability of the fire pump and creates a personnel safety hazard. A review of the manufacturing history has indicated that the majority of the affected pumps were sold within the European Union but there are units known to be in the Middle East and Asia.

Hazard Involved: The adapter plate, when subjected to coupling misalignment, may result in a catastrophic failure (See Figure 3). The failure results in the loss of power transmission between the diesel engine and the fire pump. This failure will result in the loss of the water supply to the automatic sprinkler system. **Additionally – This failure mechanism creates a personnel safety hazard. Portions of the engine adapter plate and coupling may become dislodged and eject at high velocity.**

Figure 3 – Failed Flywheel Adapter Plate
