## Product Alert – Victaulic® FireLock™ IGS™ Installation-Ready™ Style V9 Sprinkler Couplings

### Type of Notification: Performance Related Concern

**Victaulic® FireLock™ IGS™ Installation-Ready™ Style V9 Sprinkler Coupling  
Limited Hardware Affected by Non-Conformance**

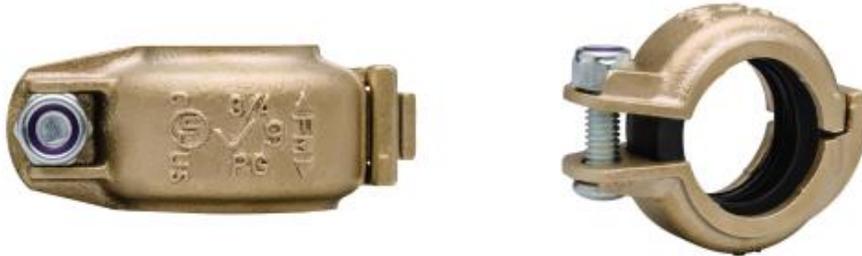
Victaulic is aware of a hazard associated with a small number of Style V9 Sprinkler Couplings. The affected couplings were determined to have weakened cap screws that secure the coupling housings due to a manufacturing non-conformance. The potential for affected cap screws exists in couplings manufactured between May 2020 and October 2021. The manufacturing date of the product is located on the interior surface of the coupling housings, therefore, please contact Victaulic for additional information and assistance.

The Style V9 Sprinkler Coupling is secured on one side using a single cap screw and locking nut while the other side is hinged. In couplings with affected cap screws, if the cap screw breaks, the coupling will separate and release the coupling and connected sprinkler from the system piping and result in water discharge from the system outlet. Sprinklers installed using the Style V9 coupling will still perform as intended in response to fire.

Style V9 Sprinkler Couplings manufactured before May 2020 or after October 2021 are not affected by the above non-conformance. Please contact Victaulic if you have questions or believe affected products may be installed in your facility.
