Product Alert

Type of Notification: Counterfeit

Description: ¹/₂" NPT frangible bulb type automatic sprinkler

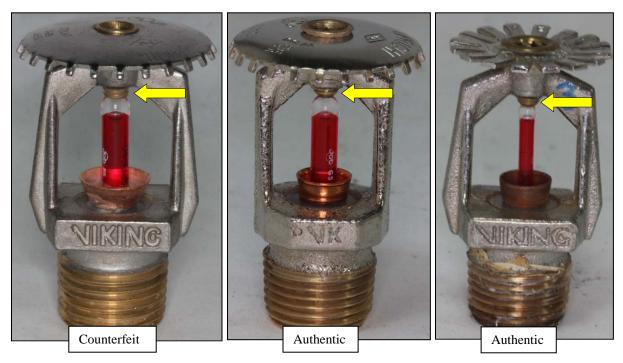
Thomas G. McCarty FM Approvals, Quality Department Norwood, MA, USA +1 (1)781 255 4802 Email: Thomas.mccarty@fmapprovals.com Figure 1 below shows a comparison of the frame of the sprinkler identified as counterfeit on the left to the frame of an authentic Viking VK100 in the middle. The new VK100 uses a frame noticeably different in shape. The "VIKING" marking is no longer applied to the wrench boss of new authentic sprinklers, instead only the letters "VK" appear. Also shown at right is an older authentic Viking sprinkler after which the counterfeit sprinkler appears to be modeled. There are greater similarities in the shape of the frame. The font used for the wrench boss marking differs between the counterfeit and authentic sprinklers. The counterfeit also has a lower luster chrome plating with a smoother appearance. The rougher appearance of the authentic sprinkler frame is thought to be due to the sand casting process used to produce it, while the counterfeit appears to be a forged/pressed piece.

The yellow arrows in Figure 1 show the protrusion of the tip of the load screw used to impart force on the orifice seal. The load screw used in the counterfeit has threads cut down to the tip where it contacts the dome of the glass bulb. In both versions of the authentic Viking sprinklers, the load screw has a taper in the last one to two millimeters of length.

Figure 1 – Comparison of the counterfeit frame (left) to the new Viking "compact" frame (middle) and an authentic older style Viking frame (right)

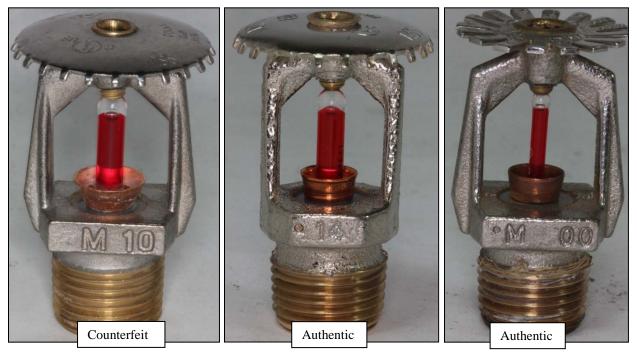
Figure 2 on the next page shows the opposite sides of the three sprinklers pictured in Figure 1. The wrench boss marking on the new authentic Viking frame, pictured middle, only shows the two digit year of manufacture "14" and drops the previously used model series designation "M." The counterfeit sprinkler to the left uses a marking scheme very similar to the older authentic Viking sprinkler pictured at right.

Figure 2 - Comparison of the counterfeit frame (left) to the new Viking "compact" frame (middle) and an authentic older style Viking frame (right)

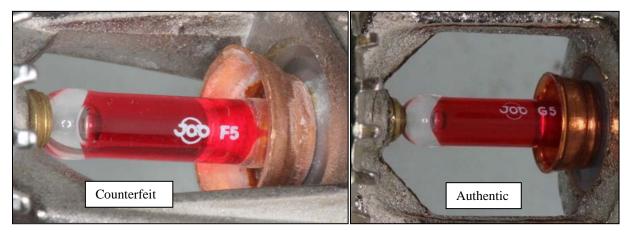
Figure 3 below shows close views of the glass bulbs used in the counterfeit sprinkler (left) and an authentic Viking VK100 sprinkler (right). The counterfeit sprinklers obtained use Job F5 5mm diameter glass bulbs, while authentic Viking VK100 sprinklers only use the Job G5 bulb.

Figure 3 – Comparison of the glass bulb used in the counterfeit sprinkler (left) and an authentic Viking VK100 sprinkler (right)

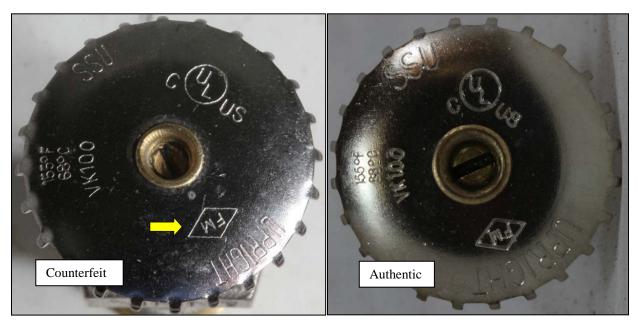
Figure 4 below shows a comparison of the deflector markings on the counterfeit sprinkler (left) and an authentic Viking VK100 sprinkler (right). The content and position of the markings on the counterfeit sprinkler are very similar to authentic sprinklers. The only discernable difference is in the font type used. The counterfeit FM Approvals marking can be seen in the lower right quadrant of the left photograph, highlight by the yellow arrow.

Figure 4 – Deflector markings stamped into the deflector of the counterfeit sprinkler (left) and an authentic Viking VK100 sprinkler (right)
